**Flood Control Project Maintenance
Levee Inspections**

Fall 2019 Levee Maintenance Deficiency Summary Report

Sacramento River Basin

Reclamation District No. 1500 Sutter Basin

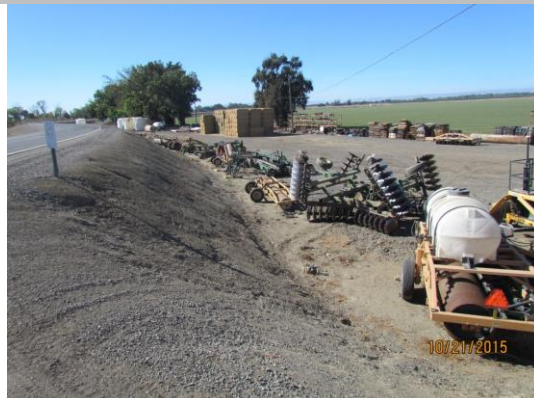
Photo 1 of 1 : FA_2019_RD1500_189_24_20190829_00008.jpg

LM Start	12.42	Rating **	M	Issue No.	24
LM End	12.53	Issue Type +	En	Location *	LS
Category	Earthen Levee			GPS Latitude/Longitude	
				Start	End
Item	Encroachments			38.868834 °	38.867492 °
				-121.760014 °	-121.760903 °
DWR ID	DWR_RD1500_01_s_2012_24				
Comment Code					
EQ : Equipment					
Inspector Comment

View of the equipment on the landward side of the levee looking upstream. Fall 2015.

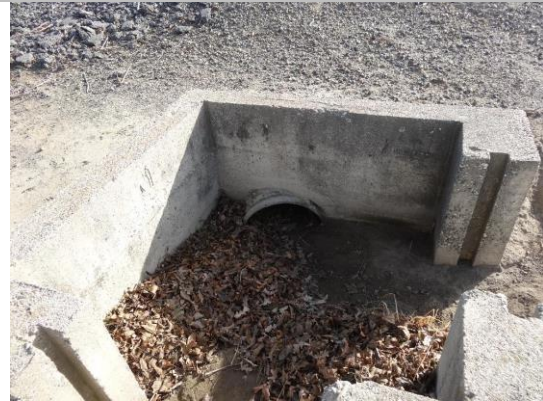
Photo 2 of 3 : UCIP_FA_2019_50197_52424.jpg

Comment Code						
Inspector Comment						
DS_ID:20063 FS_ID:50197 EP_NO: 10061 Repair Type: Non-Urgent Crossing Status: Found UCIP Comments: 08/29/2016 Same as last inspection. (K. Fazel - UCIP)01/10/2014 Needs proper abandonement. (P. Amatya - DWR) FIELD_STRUCT_DESC: *ABANDONED* 18-inch corrugated metal gravity drainage pipe through the levee, 15 feet below the crown. Slide gate in a 4-foot by 4-foot concrete box at the waterside (WS) toe. Concrete box at the landside (LS) toe. Pipe crosses overflow area to the river. Installed by USACE in 1944. (18-inch corrugated metal gravity drainage pipe through the levee and all other appurtenances retained under Automatic Board Order (ABO) issued as Permit No. 10061, 1974 - Roger L. Matteoli). [Additional Reference(s): DWR Levee Log, 2005. USACE Sacramento O&M Manual 128, March 1960, (HLM 12.69)]. FS Date: 8/29/2016

LS view: concrete intake box on levee toe.

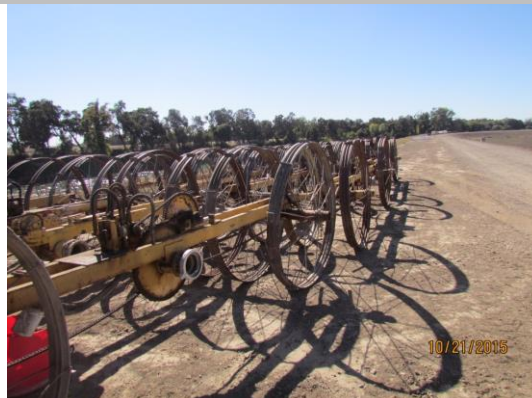
Photo 1 of 1 : FA_2019_RD1500_189_119_20190829_00056.jpg

LM Start	13.78	Rating **	M	Issue No.	119
LM End	13.82	Issue Type +	En	Location *	WS
Category	Earthen Levee			GPS Latitude/Longitude	
				Start	End
Item	Encroachments			38.859679 °	38.859201 °
				-121.780862 °	-121.781276 °
DWR ID	DWR_RD1500_01_f_2015_119				
Comment Code					
EQ : Equipment					
Inspector Comment

View of the equipment on the crown of the levee looking upstream. Fall 2015.

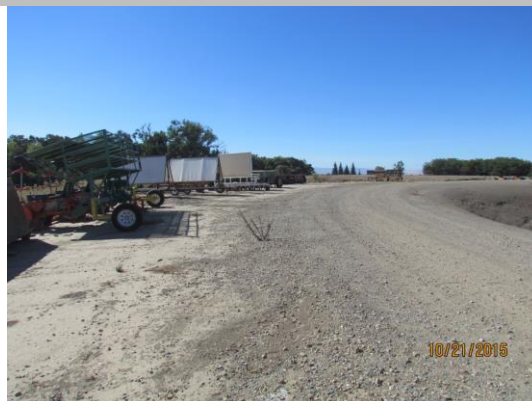
Photo 1 of 1 : FA_2019_RD1500_189_28_20190829_00011.jpg

LM Start	13.96	Rating **	M	Issue No.	28
LM End	13.96	Issue Type +	En	Location *	WS
Category	Earthen Levee			GPS Latitude/Longitude	
				Start	End
Item	Encroachments			38.857625 °	38.857625 °
				-121.782832 °	-121.782832 °
DWR ID	DWR_RD1500_01_s_2012_28				
Comment Code					
EQ : Equipment					
Inspector Comment					
Equipment are on the waterside shoulder but does not obstruct access.

View of the equipment on the crown side of the levee looking upstream. Fall 2015.

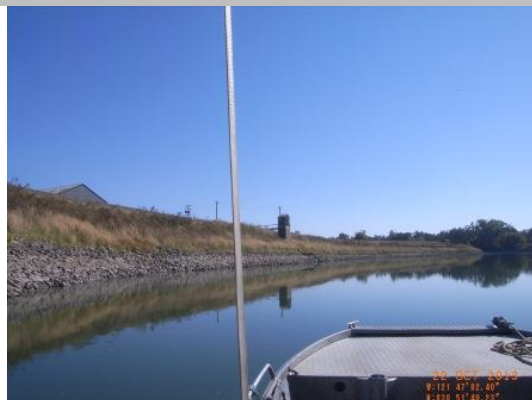
Photo 1 of 1 : FA_2019_RD1500_189_89_20190829_00036.jpg

LM Start	13.98	Rating **	A/W	Issue No.	89
LM End	14.28	Issue Type +	Ma	Location *	WS
Category	Supplemental			GPS Latitude/Longitude	
				Start	End
Item	2017 USACE Erosion Survey			38.857239 °	38.861899 °
				-121.783771 °	-121.784057 °
DWR ID	DWR_RD1500_01_f_2018_89				
Comment Code					
Inspector Comment					
2017 Site ID: SAC 99.0 L					
Status: Eroding					
2017 Field Notes: Rock continues to unravel.					
Site History: 1997 - Intermittent toe failure of the hand placed riprap;					
failure of toe materials.

USACE 2013 Photo #1

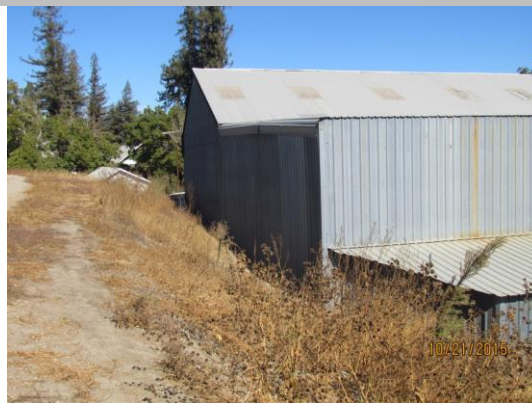
Photo 1 of 1 : FA_2019_RD1500_189_30_20190829_00012.jpg

LM Start	14.19	Rating **	M	Issue No.	30
LM End	14.19	Issue Type +	En	Location *	LS
Category	Earthen Levee			GPS Latitude/Longitude	
				Start	End
Item	Encroachments			38.860624 °	38.860624 °
				-121.783324 °	-121.783324 °
DWR ID	DWR_RD1500_01_s_2012_30				
Comment Code					
BU : Building					
Inspector Comment					
Concrete stemwall into levee embankment.

View of the building on the landward side of the levee looking upstream. Fall 2015.

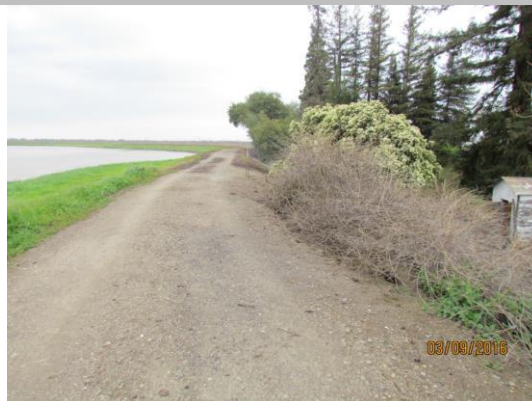
Photo 1 of 1 : FA_2019_RD1500_189_31_20190829_00013.jpg

LM Start	14.24	Rating **	M	Issue No.	31
LM End	14.25	Issue Type +	En	Location *	LS
Category	Earthen Levee			GPS Latitude/Longitude	
				Start	End
Item	Vegetation			38.861335 °	38.861385 °
				-121.783605 °	-121.783621 °
DWR ID	DWR_RD1500_01_s_2012_31				
Comment Code					
V6 : Landscaping					
Inspector Comment

View of the landscaping on the landward side of the levee looking upstream. Spring 2016.

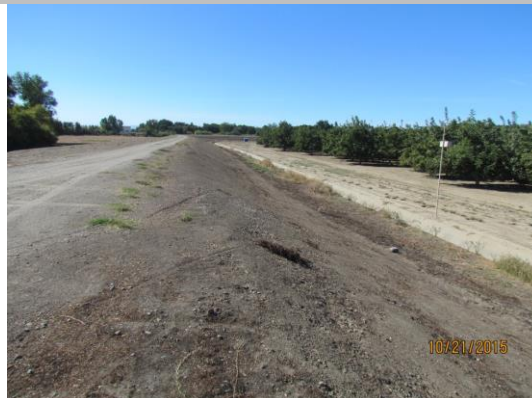
Photo 1 of 1 : FA_2019_RD1500_189_969_20190829_00074.jpg

LM Start	14.71	Rating **	M	Issue No.	969
LM End	15.76	Issue Type +	En	Location *	LS
Category	Earthen Levee			GPS Latitude/Longitude	
				Start	End
Item	Encroachments			38.865395 °	38.871827 °
				-121.789402 °	-121.804158 °
DWR ID	DWR_RD1500_01_s_2012_969				
Comment Code					
DT : Ditch					
Inspector Comment					
There is a ditch at the levee toe.

View of the ditch on the landward side of the levee looking upstream.
Fall 2015.

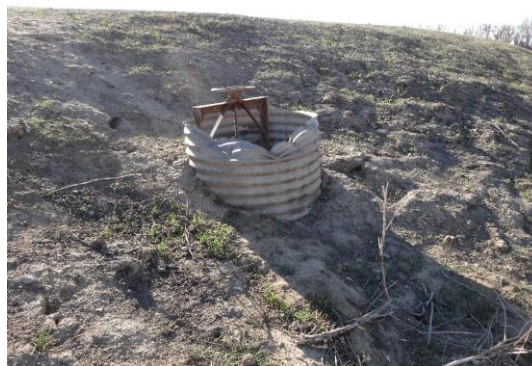
Photo 1 of 3 : UCIP_FA_2019_28489_52479.jpg

Comment Code						
Inspector Comment						
DS_ID:20081 FS_ID:28489 EP_NO: 8510 Repair Type: Non-Urgent Crossing Status: Found UCIP Comments: Pipe not visible on river bank.Cleaning and clearing require around slide gates. May be abandoned. FIELD_STRUCT_DESC: 24-inch corrugated metal irrigation discharge pipe through the levee, 15 feet below the crown. Slide gate in a 36-inch corrugated metal pipe (CMP) riser on the waterside (WS) slope. Slide gate on a concrete U-shaped headwall and irrigation ditch at the landside (LS) toe. (24-inch corrugated metal irrigation discharge pipe through the levee retained under Permit No. 8510, 1972 - John Clauss Jr. et al.). [Additional Reference(s): DWR Levee Log, 1990. USACE Sacramento O&M Manual 128, March 1960, (HLM 17.14)]. FS Date: 1/14/2014

WS view: CMP riser with slide gate on levee slope.

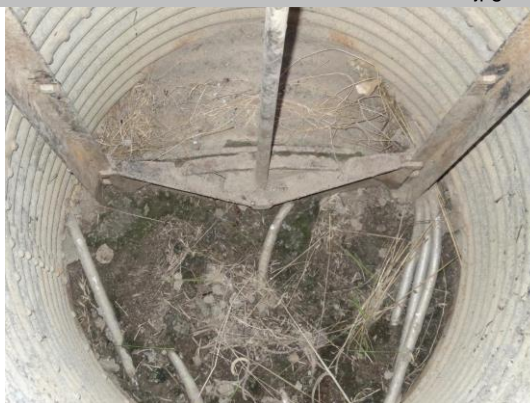
Photo 2 of 3 : UCIP_FA_2019_28489_52478.jpg

WS view: cleaning and clearing require around slide gate in CMP riser.

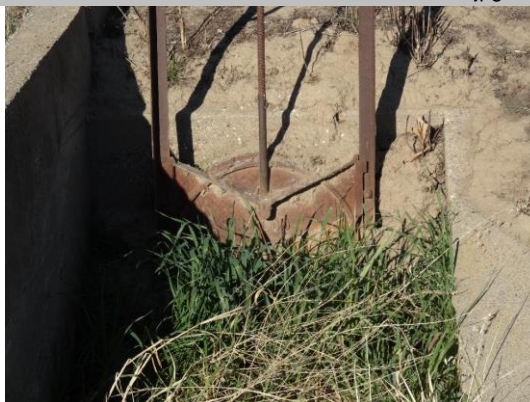
Photo 3 of 3 : UCIP_FA_2019_28489_52477.jpg

LS view: U type concrete headwall with slide gate on levee toe.

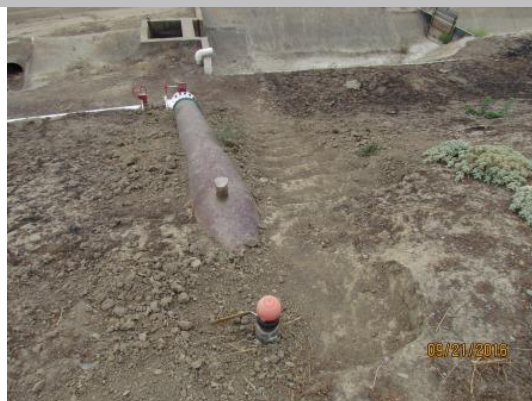
Photo 1 of 1 : FA_2019_RD1500_189_117_20190829_00053.jpg

LM Start	17.27	Rating **	M	Issue No.	117
LM End	17.27	Issue Type +	En	Location *	LS
Category	Earthen Levee			GPS Latitude/Longitude	
				Start	End
Item	Encroachments			38.887377 °	38.887377 °
				-121.808236 °	-121.808236 °
DWR ID	DWR_RD1500_01_f_2016_117				
Comment Code					
ST : Stairway					
Inspector Comment					
Stairway was made by digging into the levee slope.

View of stairs dug on landside levee slope. Fall 2016.

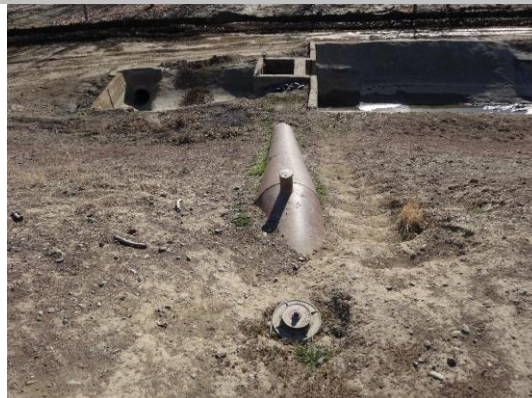
Photo 2 of 3 : UCIP_FA_2019_28490_52484.jpg

LS view: siphon breaker (bottom) without protection, exposed pipe on levee slope, and distribution box on levee toe.

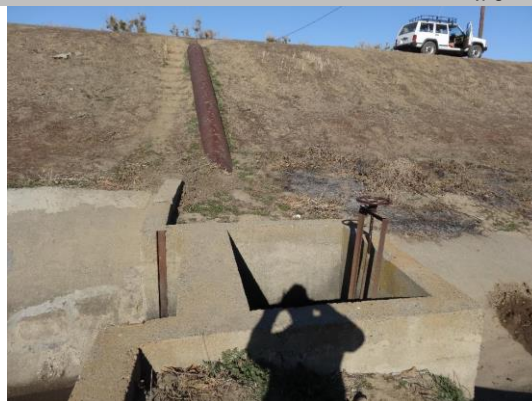
Photo 3 of 3 : UCIP_FA_2019_28490_52483.jpg

LS view: exposed pipe on levee slope, and concrete distribution box on levee toe.

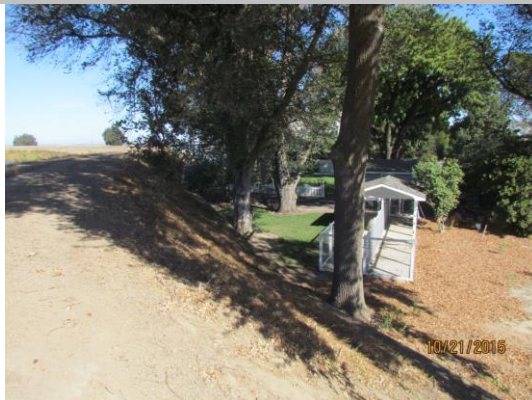
Photo 1 of 1 : FA_2019_RD1500_189_36_20190829_00014.jpg

LM Start	18.98	Rating **	M	Issue No.	36
LM End	18.98	Issue Type +	En	Location *	LS
Category	Earthen Levee			GPS Latitude/Longitude	
				Start	End
Item	Encroachments			38.901570 °	38.901570 °
				-121.791235 °	-121.791235 °
DWR ID	DWR_RD1500_01_s_2012_36				
Comment Code					
BU : Building					
Inspector Comment					
Building and concrete retaining wall are located at the toe of landside levee. The retaining wall is permitted (Permit #10065) but the building is not.

View of the building on the landward side of the levee looking upstream. Fall 2015.

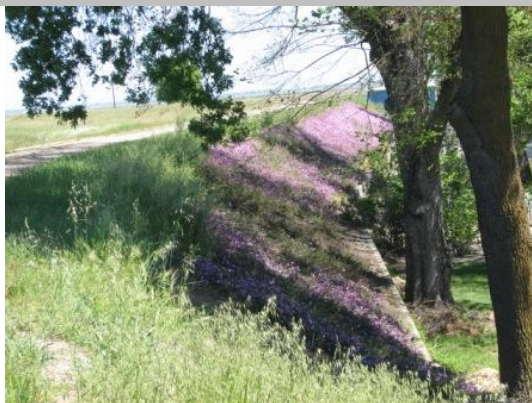
Photo 1 of 2 : FA_2019_RD1500_189_37_20190829_00015.jpg

LM Start	18.98	Rating **	M	Issue No.	37
LM End	19.04	Issue Type +	En	Location *	LS
Category	Earthen Levee			GPS Latitude/Longitude	
				Start	End
Item	Vegetation			38.901659 °	38.902383 °
				-121.791264 °	-121.790574 °
DWR ID	DWR_RD1500_01_s_2012_37				
Comment Code					
V6 : Landscaping					
Inspector Comment					
The groundcover is on the levee slope above the concrete retaining wall. The groundcover is irrigated.

View of the groundcover on the levee slope above the concrete retaining wall.

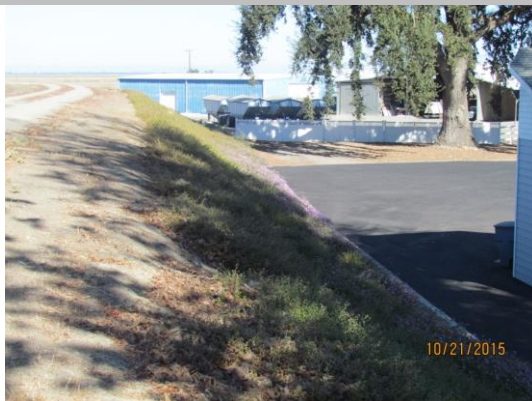
Photo 2 of 2 : FA_2019_RD1500_189_37_20190829_00016.jpg

View of the groundcover on the landward side of the levee looking upstream. Fall 2015.

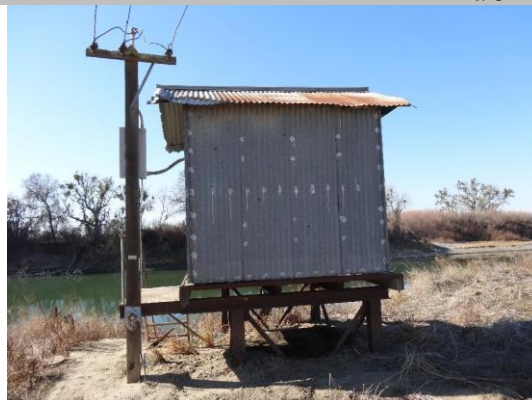
Photo 1 of 3 : UCIP_FA_2019_28506_52523.jpg

Comment Code					
Inspector Comment					
DS_ID:20087 FS_ID:28506 EP_NO: 550 Repair Type: Non-Urgent Crossing Status: Found UCIP Comments: Surface erosion on landside slope.Oil leaks from the pump. FIELD_STRUCT_DESC: 14-inch coated steel irrigation discharge pipe through the levee, 4.8 feet below the crown. Two concrete cutoff walls. Slant pump and gate valve in a corrugated metal pump house on a steel structure on the berm. Water meter installed on the pipe on the waterside (WS) slope. Screw gate at the landside (LS) end. Concrete distribution box on the LS. (Installation of a pump and a 14-inch steel discharge pipe through the levee authorized under Permit No. 550, 1931 - P. J. Hiatt. Replacement of a failing 14-inch pipe with the same size pipe through the levee authorized under Permit No. 17648, 2003 - Van Ruiten Brothers). [Additional Reference(s): DWR Levee Log, 1993. USACE Sacramento O&M Manual 128, March 1960, (HLM 19.44)]. FS Date: 1/14/2014

WS view: slant pump in CM shed on levee berm. Oil leaks from the pump.

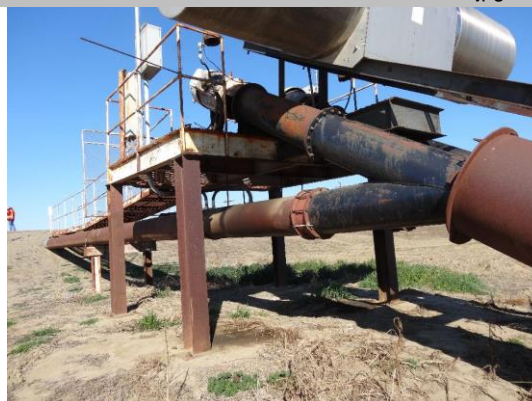
Photo 1 of 3 : UCIP_FA_2019_28524_52551.jpg

Comment Code						
Inspector Comment						
DS_ID:20004 FS_ID:28524 EP_NO: 15681 Repair Type: Non-Urgent Crossing Status: Found UCIP Comments: Obstructed siphon breakers on landside.Two 3-inch conduit through the levee.Service box on pump platform.Pumping plant was working during the field visit. FIELD_STRUCT_DESC: 1 of 2: 16-inch steel irrigation discharge pipe, asphalt coated inside and out and wrapped with asphalt saturated felt, through the levee, 1.5 feet below the crown. Cutoff wall at the centerline of the levee. Two slant pumps supported by a steel piling structure on the riverbank. Steel walkway to the pump platform. Siphon breakers in steel pipe risers on the landside (LS) shoulder. Pipe discharges into a concrete discharge box off the LS toe. (Installation of a discharge pipe through the levee and a slant pump on the riverbank authorized under Permit No. 15681, 1991 - Blackfraires Investment). FS Date: 1/14/2014

WS view: pipe, walkway, slant pump, and steel platform on levee berm.

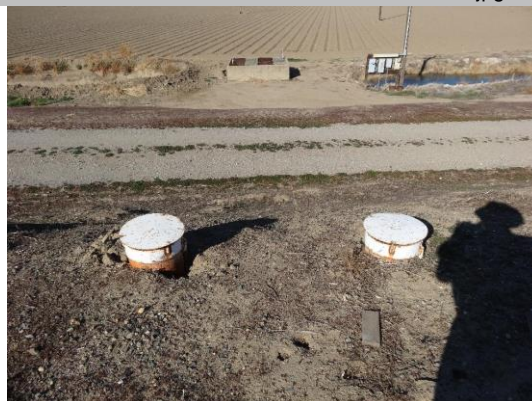
Photo 2 of 3 : UCIP_FA_2019_28524_52550.jpg

LS view: siphon breakers in steel pipe risers (bottom) on levee slope and concrete distribution (top) box on levee toe.

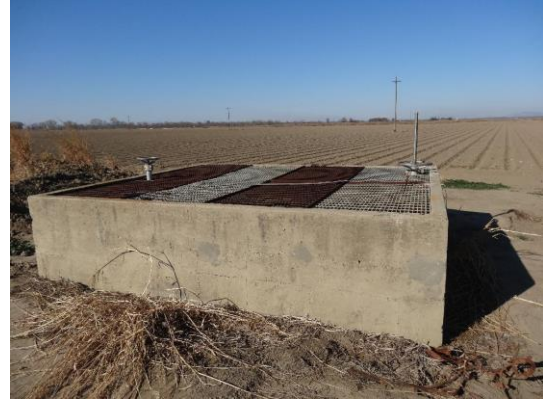
Photo 3 of 3 : UCIP_FA_2019_28524_52549.jpg

LS view: concrete distribution box on levee toe.

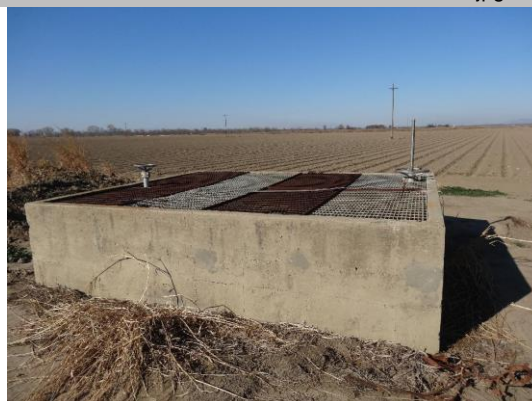
Photo 3 of 3 : UCIP_FA_2019_28927_53214.jpg

Item	DRAFT DWR UCIP Field Study			38.907028 °	38.907028 °	
				-121.792959 °	-121.792959 °	
DWR ID	20022					
Comment Code						
Inspector Comment						
DS_ID:20022 FS_ID:28927 EP_NO: 15681 Repair Type: Non-Urgent Crossing Status: Found UCIP Comments: Obstructed siphon breakers on landside.Two 3-inch conduit through the levee.Service box on pump platform.Pumping plant was working during the field visit. FIELD_STRUCT_DESC: 2 of 2: 20-inch steel irrigation discharge pipe, asphalt coated inside and out and wrapped with asphalt saturated felt, through the levee, 1.5 feet below the crown. Cutoff wall at the centerline of the levee. Two slant pumps supported by a steel piling structure on the riverbank. Steel walkway to the pump platform. Siphon breakers in steel pipe risers on the landside (LS) shoulder. Pipe discharges into a concrete discharge box off the LS toe. (Installation of a discharge pipe through the levee and a slant pump on the riverbank authorized under Permit No. 15681, 1991 - Blackfraires Investment). FS Date: 1/14/2014

LS view: concrete distribution box on levee toe.

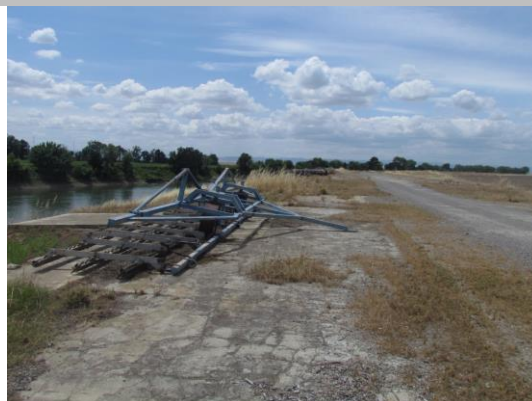
Photo 1 of 1 : FA_2019_RD1500_189_2549_20190829_00077.jpg

LM Start	19.56	Rating **	M	Issue No.	2549
LM End	19.56	Issue Type +	En	Location *	WS
Category	Earthen Levee			GPS Latitude/Longitude	
				Start	End
Item	Encroachments			38.906565 °	38.906565 °
				-121.794472 °	-121.794472 °
DWR ID	DWR_RD1500_01_s_2015_2549				
Comment Code					
EQ : Equipment					
Inspector Comment

View of the equipment on the waterward side of the levee looking upstream. Spring 2015.

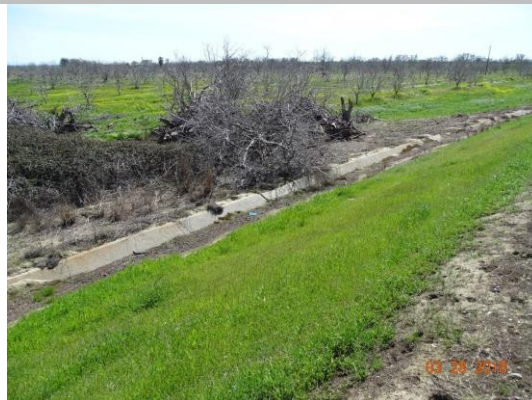
Photo 1 of 1 : FA_2019_RD1500_189_123_20190829_00061.jpg

LM Start	20.97	Rating **	M	Issue No.	123
LM End	21.15	Issue Type +	En	Location *	LS
Category	Earthen Levee			GPS Latitude/Longitude	
				Start	End
Item	Encroachments			38.910885 °	38.913199 °
				-121.804603 °	-121.803256 °
DWR ID	DWR_RD1500_01_s_2018_123				
Comment Code					
DT : Ditch					
Inspector Comment					
Ditch within landside easement.

View of ditch at the landside toe. Spring 2018.

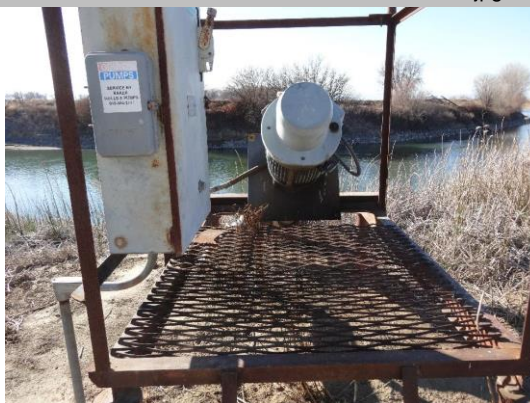
Photo 1 of 3 : UCIP_FA_2019_28527_52568.jpg

Comment Code					
Inspector Comment					
DS_ID:20070 FS_ID:28527 EP_NO: 11959A Repair Type: Non-Urgent Crossing Status: Found UCIP Comments: Siphon breaker (obstructed) in CMP on landside slope.Power pole on landside toe. FIELD_STRUCT_DESC: 10-inch coated and wrapped steel irrigation discharge pipe through the levee, 3 feet below the crown. Corrugated metal cutoff wall. Slant pump on a steel platform at the riverbank. Obstructed siphon breaker in a corrugated metal pipe (CMP) riser on the landside (LS) slope. Pipe discharges into a 6-foot by 6-foot concrete distribution box on the LS. (Replacement of an existing 10-inch steel pipe with a new 10-inch steel pipe through the levee authorized under Permit No. 11959-A, 1977 - George Van Ruiten Jr.). [Additional Reference(s): DWR Levee Log, 2005. USACE Sacramento O&M Manual 128, March 1960, (HLM 21.50)]. FS Date: 1/14/2014

WS view: slant pump on steel platform on levee berm.

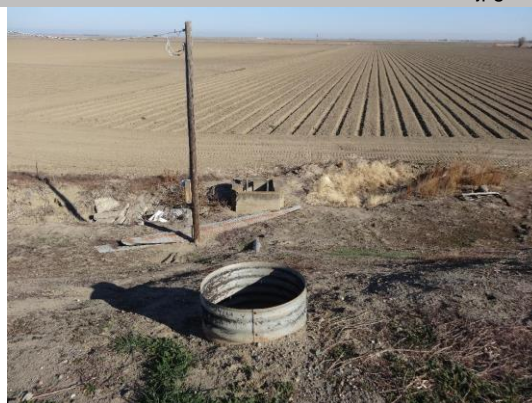
Photo 2 of 3 : UCIP_FA_2019_28527_52567.jpg

DS_ID:20070
FS_ID:28527
EP_NO: 11959A
Repair Type: Non-Urgent
Crossing Status: Found
UCIP Comments: Siphon breaker (obstructed) in CMP on landside slope. Power pole on landside toe.
FIELD_STRUCT_DESC: 10-inch coated and wrapped steel irrigation discharge pipe through the levee, 3 feet below the crown. Corrugated metal cutoff wall. Slant pump on a steel platform at the riverbank.
Obstructed siphon breaker in a corrugated metal pipe (CMP) riser on the landside (LS) slope. Pipe discharges into a 6-foot by 6-foot concrete distribution box on the LS. (Replacement of an existing 10-inch steel pipe with a new 10-inch steel pipe through the levee authorized under Permit No. 11959-A, 1977 - George Van Ruiten Jr.). [Additional Reference(s): DWR Levee Log, 2005. USACE Sacramento O&M Manual 128, March 1960, (HLM 21.50)].
FS Date: 1/14/2014

LS view: siphon breaker in CMP riser on levee slope (bottom) and concrete distribution box (top) on levee toe.

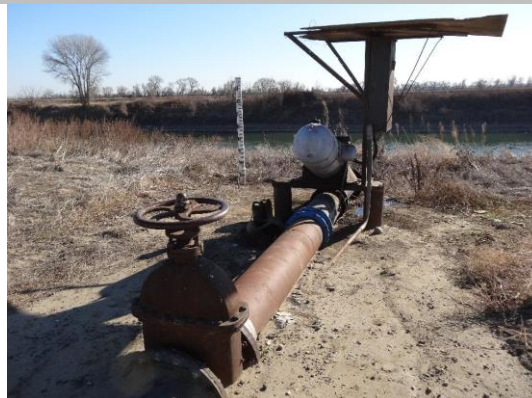
Photo 1 of 3 : UCIP_FA_2019_28528_52576.jpg

Comment Code						
Inspector Comment						
DS_ID:20071 FS_ID:28528 EP_NO: 10063 Repair Type: Non-Urgent Crossing Status: Found UCIP Comments: Water leaks near pump. Obstructed siphon breaker in CMP on landside.Plant was working during field visit. FIELD_STRUCT_DESC: 16-inch steel irrigation discharge pipe through the levee, 6.3 feet below the crown. Corrugated metal cutoff wall. 1.5-inch conduit through the levee, 6.5 feet below the crown. Slant pump and gate valve on riverbank. Siphon breaker in a 24-inch corrugated metal pipe (CMP) riser on the landside (LS) slope. 5-foot by 5-foot concrete distribution box on the LS. CMP standpipe on the LS toe. Power pole and one anchor at the LS toe. (Automatic Board Order (ABO) issued as Permit No. 10063, 1974 - Thomas L. Nelson). [Additional Reference(s): DWR Levee Log, 2005. USACE Sacramento O&M Manual 128, March 1960, (HLM 21.83)]. FS Date: 1/14/2014

WS view: slant pump on steel platform on levee berm. Exposed steel pipe with gate valve also on levee berm.

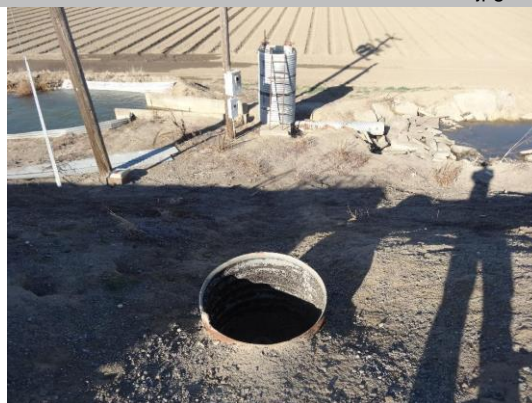
Photo 3 of 3 : UCIP_FA_2019_28528_52574.jpg

Item	DRAFT DWR UCIP Field Study			38.916180 °	38.916180 °	
				-121.808904 °	-121.808904 °	
DWR ID	20071					
Comment Code						
Inspector Comment						
DS_ID:20071 FS_ID:28528 EP_NO: 10063 Repair Type: Non-Urgent Crossing Status: Found UCIP Comments: Water leaks near pump. Obstructed siphon breaker in CMP on landside.Plant was working during field visit. FIELD_STRUCT_DESC: 16-inch steel irrigation discharge pipe through the levee, 6.3 feet below the crown. Corrugated metal cutoff wall. 1.5-inch conduit through the levee, 6.5 feet below the crown. Slant pump and gate valve on riverbank. Siphon breaker in a 24-inch corrugated metal pipe (CMP) riser on the landside (LS) slope. 5-foot by 5-foot concrete distribution box on the LS. CMP standpipe on the LS toe. Power pole and one anchor at the LS toe. (Automatic Board Order (ABO) issued as Permit No. 10063, 1974 - Thomas L. Nelson). [Additional Reference(s): DWR Levee Log, 2005. USACE Sacramento O&M Manual 128, March 1960, (HLM 21.83)]. FS Date: 1/14/2014

LS view: siphon breaker in CMP riser on levee slope (bottom) and CMP stand pipe (top) on levee toe.

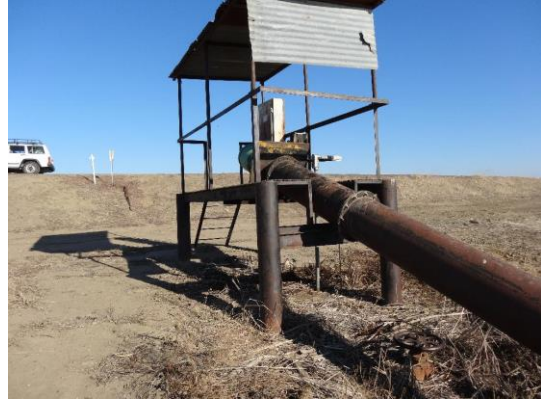
Photo 1 of 3 : UCIP_FA_2019_28583_52627.jpg

Comment Code					
Inspector Comment					
DS_ID:19995 FS_ID:28583 EP_NO: 10851 Repair Type: Non-Urgent Crossing Status: Found UCIP Comments: Exposed conduit on both slopes of the levee. Plant was working during field visit. Water was leaking from pipe joint near pump.Obstructed siphon breaker in CMP. FIELD_STRUCT_DESC: [Pumping Plant No. 2] 14-inch steel irrigation discharge pipe through the levee, 6.2 feet below the crown. Corrugated metal cutoff wall. 2-inch conduit through the levee, 5 feet below the crown. Pump and gate valve on a steel platform at the riverbank. Switch panel on the berm. Siphon breaker in a 24-inch corrugated metal pipe (CMP) riser on the landside (LS) shoulder. Pipe discharges into a 36-inch CMP standpipe at the LS toe. Meter pole at the LS toe. (Installation of three centrifugal pumps authorized under Permit No. 2895, 1958 - George Van Ruiten). [Additional Reference(s): DWR Levee Log, 1993. USACE Sacramento O&M Manual 128, March 1960, (HLM 23.00), 14-inch pipe referenced]. FS Date: 1/14/2014

WS view: slant pump on steel platform on levee berm.

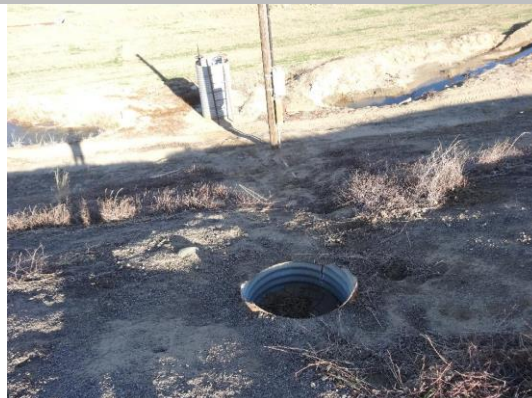
Photo 3 of 3 : UCIP_FA_2019_28583_52625.jpg

Item	DRAFT DWR UCIP Field Study			38.919717°	38.919717°	
				-121.829113°	-121.829113°	
DWR ID	19995					
Comment Code						
Inspector Comment						
DS_ID:19995 FS_ID:28583 EP_NO: 10851 Repair Type: Non-Urgent Crossing Status: Found UCIP Comments: Exposed conduit on both slopes of the levee. Plant was working during field visit. Water was leaking from pipe joint near pump.Obstructed siphon breaker in CMP. FIELD_STRUCT_DESC: [Pumping Plant No. 2] 14-inch steel irrigation discharge pipe through the levee, 6.2 feet below the crown. Corrugated metal cutoff wall. 2-inch conduit through the levee, 5 feet below the crown. Pump and gate valve on a steel platform at the riverbank. Switch panel on the berm. Siphon breaker in a 24-inch corrugated metal pipe (CMP) riser on the landside (LS) shoulder. Pipe discharges into a 36-inch CMP standpipe at the LS toe. Meter pole at the LS toe. (Installation of three centrifugal pumps authorized under Permit No. 2895, 1958 - George Van Ruiten). [Additional Reference(s): DWR Levee Log, 1993. USACE Sacramento O&M Manual 128, March 1960, (HLM 23.00), 14-inch pipe referenced]. FS Date: 1/14/2014

LS view: siphon breaker in CMP riser on levee slope (bottom) and CMP stand pipe (top) on levee toe.

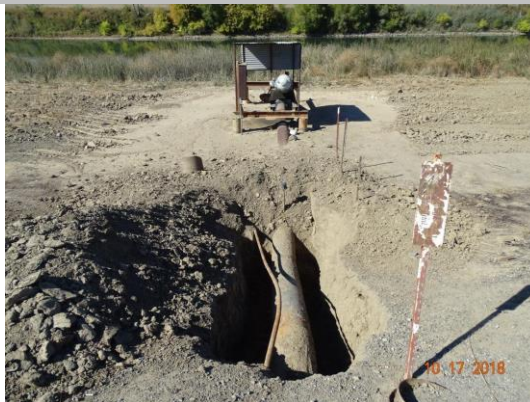
Photo 2 of 3 : UCIP_FA_2019_53023_78167.jpg

Levee crown view: WS levee slope was excavated to do pipe maintenance, photo courtesy of Zach Jojola.

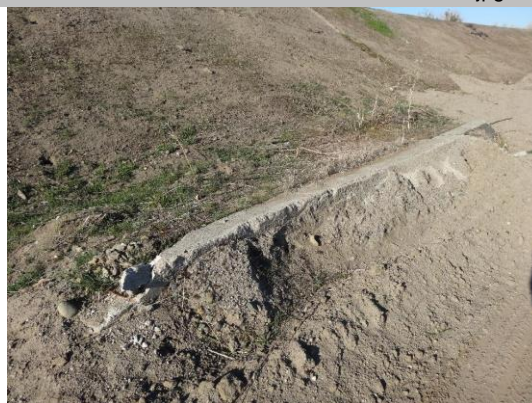
Photo 2 of 2 : UCIP_FA_2019_41728_52672.jpg

Item	DRAFT DWR UCIP Field Study			38.952803 °	38.952803 °	
				-121.837618 °	-121.837618 °	
DWR ID	20074					
Comment Code						
Inspector Comment						
DS_ID:20074 FS_ID:41728 EP_NO: 8765 Repair Type: Non-Urgent Crossing Status: Found UCIP Comments: Burried Concrete headwall on landside toe. Should verify pipe has been properly abandoned.Utility tag plate on waterside shoulder.No pipe found. FIELD_STRUCT_DESC: *ABANDONED* 48-inch by 48-inch reinforced concrete box irrigation discharge culvert through the levee, 10 feet below the crown. (48-inch by 48-inch concrete culvert retained under Permit No. 9175, 1973 - David S. Lewis, DBA Broomieside Farms. To sleeve a 20-inch steel irrigation discharge pipe through the existing concrete culvert from a new slant-type pumping facility authorized under Permit No. 8765, 1973 - David S. Lewis, DBA Broomieside Farms. The 20-inch discharge pipe will be enclosed in a 30-inch, 0.375-inch wall steel pipe.). [Additional Reference(s): DWR Levee Log, 2005. USACE Sacramento O&M Manual 128, March 1960, (HLM 25.80)]. FS Date: 1/15/2014

LS view: concrete headwall on landside toe. No pipe found.

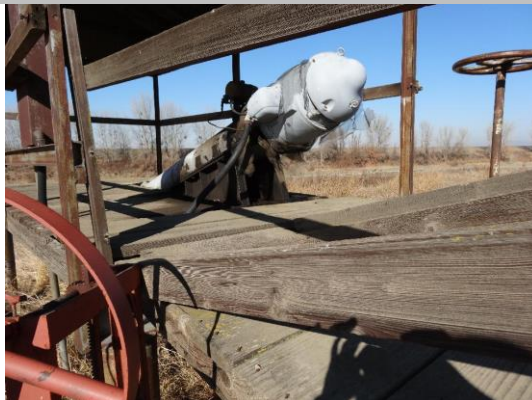
Photo 1 of 3 : UCIP_FA_2019_28631_52720.jpg

Comment Code					
Inspector Comment					
DS_ID:20015 FS_ID:28631 EP_NO: 10052 Repair Type: Non-Urgent Crossing Status: Found UCIP Comments: Obstructed siphon breaker. Leaky pump. FIELD_STRUCT_DESC: 18-inch steel irrigation discharge pipe through the levee, 7.1 feet below the crown. Corrugated metal cutoff wall. 2-inch conduit through the levee, 5.5 feet below the crown. Wooden walkway to slant pump and gate valve on wooden pump platform mounted on a steel pile structure on the berm. Siphon breaker in a 24-inch corrugated metal pipe (CMP) riser on the landside (LS) slope. Meter pole at the LS toe. (18-inch steel irrigation discharge pipe through the levee, slant pump, and all other appurtenances retained under Automatic Board Order (ABO) issued as Permit No. 10052, 1974 - Clifton Lamb, [RM 112.29]). [Additional Reference(s): DWR Levee Log, 1993. USACE Sacramento O&M Manual 128, March 1960, (HLM 27.07)]. FS Date: 1/15/2014

WS view: slant pump and gate valves on wooden platform at levee berm. Wooden walkway to the pump.

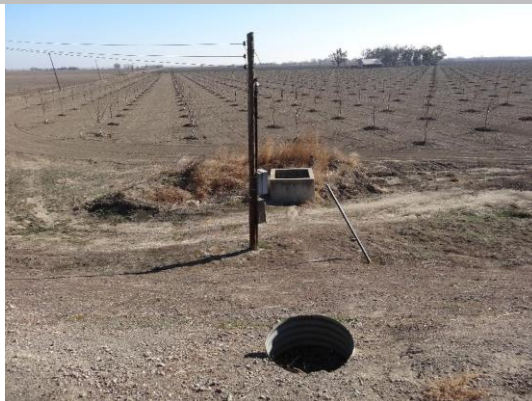
Photo 2 of 3 : UCIP_FA_2019_28631_52719.jpg

LS view: siphon breaker in CMP riser on levee slope (bottom) and concrete distribution box on levee toe.

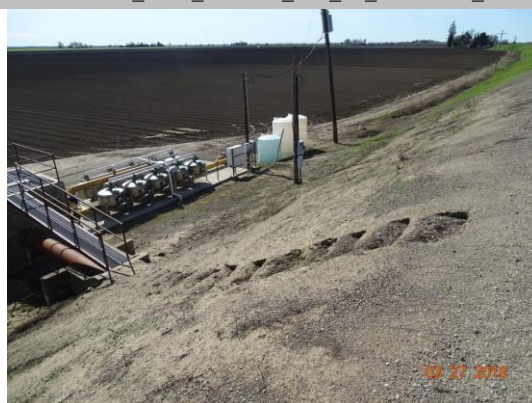
Photo 1 of 1 : FA_2019_RD1500_189_96_20190829_00040.jpg

LM Start	28.16	Rating **	M	Issue No.	96
LM End	28.16	Issue Type +	En	Location *	LS
Category	Earthen Levee			GPS Latitude/Longitude	
				Start	End
Item	Encroachments			38.982180 °	38.982180 °
				-121.819979 °	-121.819979 °
DWR ID	DWR_RD1500_01_s_2018_96				
Comment Code					
ST : Stairway					
Inspector Comment					
Steps are dug out on the landside levee slope.

View of steps on the landside slope. Spring 2018.

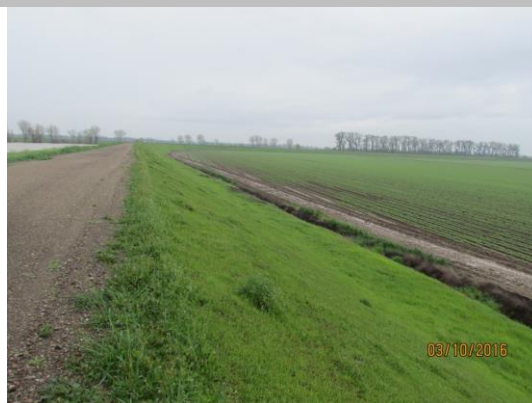
Photo 1 of 1 : FA_2019_RD1500_189_38_20190829_00017.jpg

LM Start	28.23	Rating **	M	Issue No.	38
LM End	29.23	Issue Type +	En	Location *	LS
Category	Earthen Levee			GPS Latitude/Longitude	
				Start	End
Item	Encroachments			38.983119 °	38.988538 °
				-121.819923 °	-121.806445 °
DWR ID	DWR_RD1500_01_s_2012_38				
Comment Code					
DT : Ditch					
Inspector Comment

View of the ditch on the landward side of the levee looking upstream. Spring 2016.

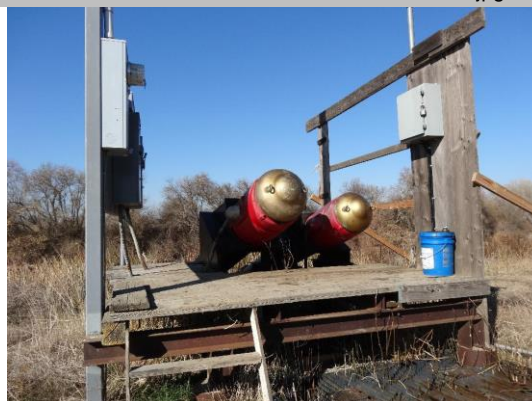
Photo 1 of 3 : UCIP_FA_2019_50194_51834.jpg

Comment Code						
Inspector Comment						
DS_ID:20113 FS_ID:50194 EP_NO: 10054 Repair Type: Non-Urgent Crossing Status: Found UCIP Comments: 08/29/2016: Found no evidence of leakage or subsidence. CMP risers are both silted in and need lids. Need a name change permit for new owner Brad Howalt. Possible sink hole in alignment with pipes on crown has been covered with concrete. Crossing has been downgraded from Urgent to Non-Urgent. (K. Fazel - UCIP)01/15/2014:Levee slope erosion due to leakage from siphon breaker.Water leaking from pipe near distribution box on landside levee toe.Overhead powerline. (P. Amatya - DWR) FIELD_STRUCT_DESC: 2 of 2: 16-inch steel irrigation discharge pipe through the levee, 5 feet below the crown. Corrugated metal cutoff wall. Two siphon breakers in two 24-inch corrugated metal pipe (CMP) risers on the landside (LS) shoulder. Installed by USACE in 1952. Two slant pumps in a corrugated metal pump house mounted on a steel pile structure on the berm. 4-foot by 7-foot concrete inspection box for a Hersey-Sparling water meter on the berm in front of the pump house. Two flap gates in a 9.7-foot by 10.6-foot, outside dimensions, concrete distribution box at the LS toe. (16-inch steel irrigation discharge pipe through the levee, slant pumps, and all other appurtenances retained under Automatic Board Order (ABO) issued as Permit No. 10054, 1974 - William A. Lerner). [Additional Reference(s): DWR Levee Log, 1993. USACE Sacramento O&M Manual 128, March 1960, (HLM 30.29), 14-inch pipe referenced]. FS Date: 8/29/2016

WS view: two slant pumps on wooden platform on levee berm.

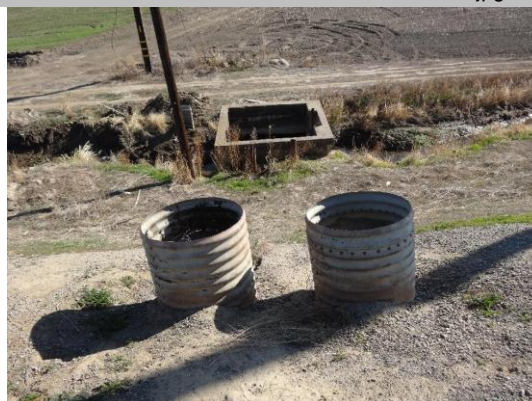
Photo 3 of 3 : UCIP_FA_2019_50194_52880.jpg

Item	DRAFT DWR UCIP Field Study			38.993006 °	38.993006 °	
				-121.796025 °	-121.796025 °	
DWR ID	20113					
Comment Code						
Inspector Comment						
DS_ID:20113 FS_ID:50194 EP_NO: 10054 Repair Type: Non-Urgent Crossing Status: Found UCIP Comments: 08/29/2016: Found no evidence of leakage or subsidence. CMP risers are both silted in and need lids. Need a name change permit for new owner Brad Howalt. Possible sink hole in alignment with pipes on crown has been covered with concrete. Crossing has been downgraded from Urgent to Non-Urgent. (K. Fazel - UCIP)01/15/2014:Levee slope erosion due to leakage from siphon breaker.Water leaking from pipe near distribution box on landside levee toe.Overhead powerline. (P. Amatya - DWR) FIELD_STRUCT_DESC: 2 of 2: 16-inch steel irrigation discharge pipe through the levee, 5 feet below the crown. Corrugated metal cutoff wall. Two siphon breakers in two 24-inch corrugated metal pipe (CMP) risers on the landside (LS) shoulder. Installed by USACE in 1952. Two slant pumps in a corrugated metal pump house mounted on a steel pile structure on the berm. 4-foot by 7-foot concrete inspection box for a Hersey-Sparling water meter on the berm in front of the pump house. Two flap gates in a 9.7-foot by 10.6-foot, outside dimensions, concrete distribution box at the LS toe. (16-inch steel irrigation discharge pipe through the levee, slant pumps, and all other appurtenances retained under Automatic Board Order (ABO) issued as Permit No. 10054, 1974 - William A. Lerner). [Additional Reference(s): DWR Levee Log, 1993. USACE Sacramento O&M Manual 128, March 1960, (HLM 30.29), 14-inch pipe referenced]. FS Date: 8/29/2016

LS view: siphon breakers in CMP riser on levee slope and distribution box on levee toe.

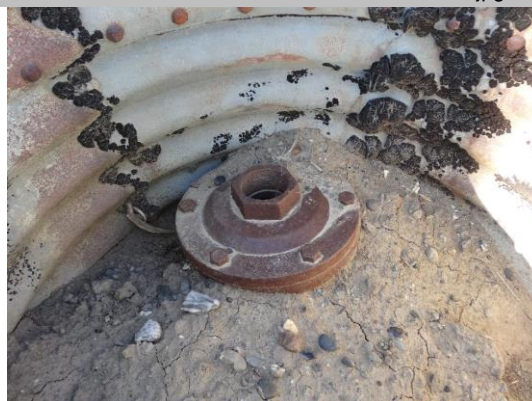
Photo 3 of 3 : UCIP_FA_2019_50201_52853.jpg

Item	DRAFT DWR UCIP Field Study			38.993006 °	38.993006 °	
				-121.796025 °	-121.796025 °	
DWR ID	20084					
Comment Code						
Inspector Comment						
DS_ID:20084 FS_ID:50201 EP_NO: 10054 Repair Type: Non-Urgent Crossing Status: Found UCIP Comments: 08/29/2016: Found no evidence of leakage or subsidence. CMP risers are both silted in and need lids. Need a name change permit for new owner Brad Howalt. Possible sink hole in alignment with pipes on crown has been covered with concrete. Crossing has been downgraded from Urgent to Non-Urgent. (K. Fazel - UCIP)01/15/2014:Levee slope erosion due to leakage from siphon breaker.Water leaking from pipe near distribution box on landside levee toe.Overhead powerline. (P. Amatya - DWR) FIELD_STRUCT_DESC: 1 of 2: 20-inch steel irrigation discharge pipe through the levee, 5 feet below the crown. Corrugated metal cutoff wall. Two siphon breakers in two 24-inch corrugated metal pipe (CMP) risers on the landside (LS) shoulder. Installed by USACE in 1952. Two slant pumps in a corrugated metal pump house mounted on a steel pile structure on the berm. 4-foot by 7-foot concrete inspection box for a Hersey-Sparling water meter on the berm in front of the pump house. Two flap gates in a 9.7-foot by 10.6-foot, outside dimensions, concrete distribution box at the LS toe. (20-inch steel irrigation discharge pipe through the levee, slant pumps, and all other appurtenances retained under Automatic Board Order (ABO) issued as Permit No. 10054, 1974 - William A. Lerner). [Additional Reference(s): DWR Levee Log, 1993. USACE Sacramento O&M Manual 128, March 1960, (HLM 30.29), 18-inch pipe referenced]. FS Date: 8/29/2016

LS view: obstructed and leaky siphon breaker in CMP riser on levee slope.

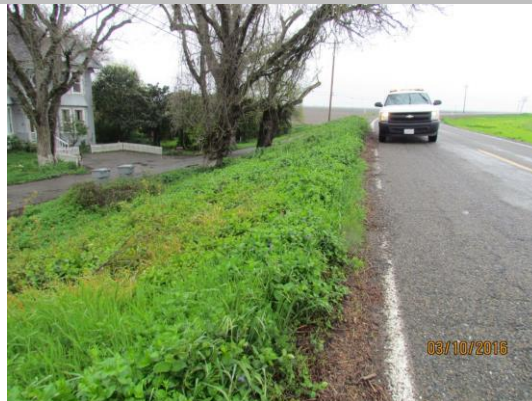
Photo 1 of 1 : FA_2019_RD1500_189_45_20190829_00019.jpg

LM Start	30.22	Rating **	M	Issue No.	45					
LM End	30.22	Issue Type +	En	Location *	LS					
Category	Earthen Levee		GPS Latitude/Longitude							
			Start	End						
Item	Vegetation		38.997027 °	38.997027 °						
			-121.794755 °	-121.794755 °						
DWR ID	DWR_RD1500_01_s_2012_45									
Comment Code										
V6 : Landscaping										
Inspector Comment

View of the groundcover on the landward side of the levee looking downstream. Spring 2016.

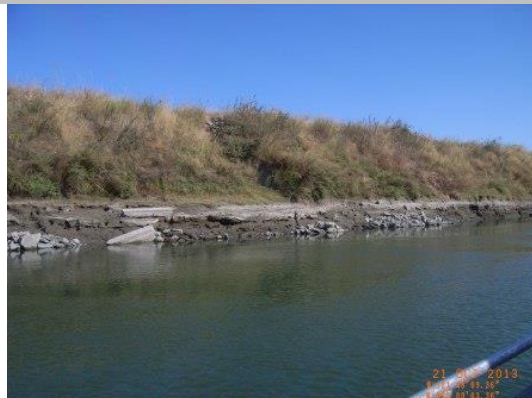
Photo 1 of 1 : FA_2019_RD1500_189_82_20190829_00030.jpg

LM Start	30.60	Rating **	A/W	Issue No.	82
LM End	30.75	Issue Type +	Ma	Location *	WS
Category	Supplemental			GPS Latitude/Longitude	
				Start	End
Item	2017 USACE Erosion Survey			38.999745 °	39.001413 °
				-121.800898 °	-121.802889 °
DWR ID	DWR_RD1500_01_f_2018_82				
Comment Code					
Inspector Comment					
2017 Site ID: SAC 116.0 L					
Status: Eroding					
2017 Field Notes: Minor new erosion throughout the site.					
Site History: 2000 - Eroding, vertical berm slope over a vertical cohesive toe; slow erosion but getting close to the toe. 2002 - Erosion is getting close to the levee, still eroding with some new small slumps.					
2004 - Some minor new erosion. 2006 - Some new erosion, cleaned off older scars and slump faces. 2008 - New, small, partial rotational failure. 2011 - Some new minor erosion. 2016 - Fresh erosion on lower bank.

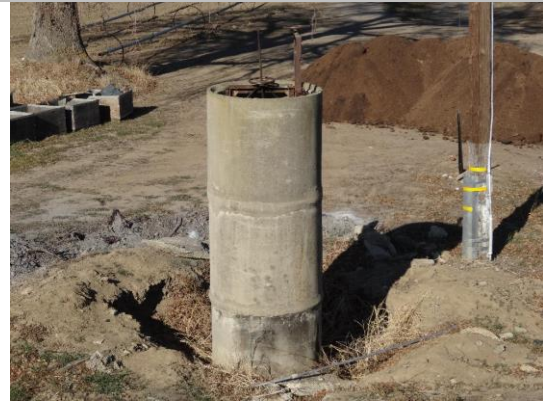
Photo 3 of 3 : UCIP_FA_2019_28143_51803.jpg

Item	DRAFT DWR UCIP Field Study			39.006484 °	39.006484 °	
				-121.816168 °	-121.816168 °	
DWR ID	20077					
Comment Code						
Inspector Comment						
DS_ID:20077 FS_ID:28143 EP_NO: 9657 Repair Type: Non-Urgent Crossing Status: Found UCIP Comments: Looks abandoned. May need proper abandonment.Overhead power line. FIELD_STRUCT_DESC: *ABANDONED* 20-inch steel irrigation discharge pipe through the levee, 15 feet below the crown. Wooden step and walkway to vertical pump on pile structure in the river. Slide gate in a 2.5-foot by 3-foot, inside dimensions, riser. Concrete distribution box on the waterside (WS) slope. Switch panel on the berm. Pipe discharges into a 36-inch, inside diameter, concrete standpipe on the landside (LS). Installed by USACE in 1947. (Replacement of a section of 24-inch irrigation pipe through the levee authorized under Permit No. 9657, 1974 - Clyde M. Bell. 1.5-foot by 2-foot concrete culvert through the levee and all other appurtenances retained under Automatic Board Order (ABO) issued as Permit No. 10030, 1974 - Clyde M. Bell. Replacement of a cracked concrete pipe with a steel pipe at the LS toe authorized under Permit No. 13536, 1982 - Niechen N. V., Alfred Montna, Manager. Replacement of approximately 90 feet of 18-inch pipe in the overflow area of the Sacramento River with new steel pipe authorized under Permit No. 13941, 1984 - Niechen N. V., Alfred Montna, Manager). [Additional Reference(s): DWR Levee Log, 2005. USACE Sacramento O&M Manual 128, March 1960, (HLM 32.02), 2-foot by 2-foot concrete culvert referenced]. FS Date: 1/15/2014

LS view: concrete standpipe on levee toe.

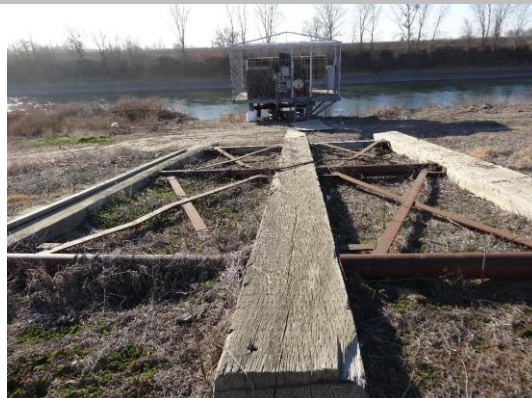
Photo 1 of 3 : UCIP_FA_2019_28952_53249.jpg

Comment Code						
Inspector Comment						
DS_ID:24758 FS_ID:28952 EP_NO: N/A Repair Type: Non-Urgent Crossing Status: Found UCIP Comments: Not found- slide gate in 54 inch corrugated metal riser on waterside berm.Two 16-inch steel pipes (looks new). Leaky pipe near pump.Plant was working during field visit.Needs more info from LMA. There may be a new permit. FIELD_STRUCT_DESC: 2 of 2: 16-inch steel irrigation discharge pipe through the levee, at an unknown depth. Two slant pumps on a steel platform and under the shed. Two air vents on the waterside (WS) levee shoulder. Two pipes with gate valves discharge water into irrigation ditch on the landside (LS). Meter pole on landside toe. Previously only a 30-inch steel pipe through the levee and a slide gate in a corrugated metal pipe (CMP) riser on the WS. (Removal of existing structure in river, installation of an incline structure next to the levee with new slant pumps, connected to existing discharge pipe authorized under Permit Nos. 5617, 1967 - Adda Seamans, and 5617-A, 1968 - Oji Brothers Farm, Inc.). [Additional Reference(s): DWR Levee Log, 2005. USACE Sacramento O&M Manual 128, March 1960, (HLM 33.56), 36-inch pipe referenced]. FS Date: 1/15/2014

WS view: pump platform and shed on levee berm.

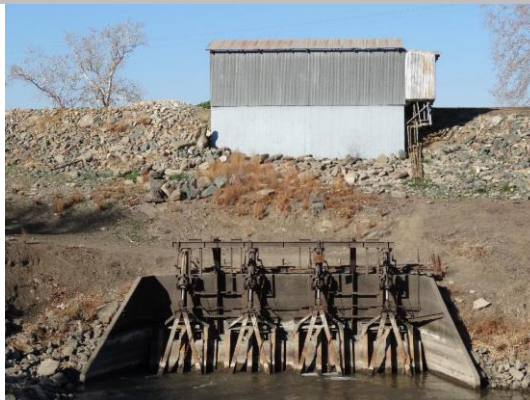
Photo 1 of 3 : UCIP_FA_2019_28883_53085.jpg

WS view: CM shed for slide gate on levee shoulder (top) and outfall structure at levee toe (bottom).

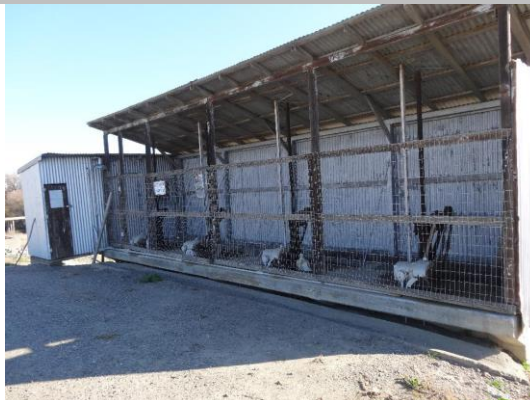
Photo 2 of 3 : UCIP_FA_2019_28883_53083.jpg

WS view: motorized slide gates in CM shed on levee shoulder.

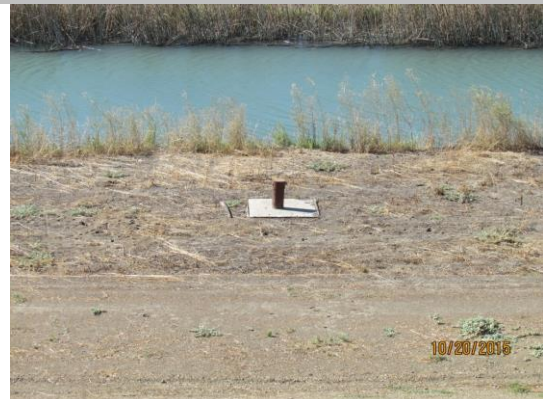
Photo 3 of 3 : FA_2019_RD1500_190_4_20190829_00003.jpg

LM Start	14.13	Rating **	U	Issue No.	4 (cont)
LM End	14.13	Issue Type +	Ma	Location *	LS

View of the relief well at historical boil 12. Fall 2015.

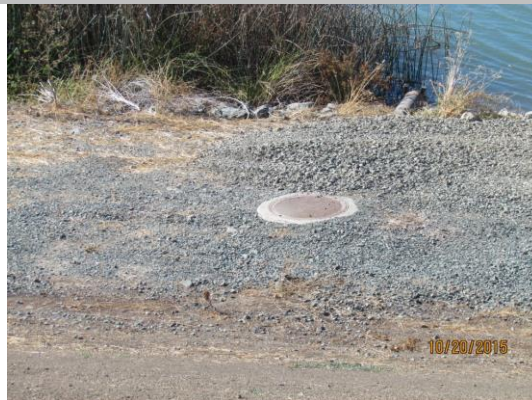
Photo 1 of 1 : FA_2019_RD1500_190_15_20190829_00008.jpg

LM Start	18.43	Rating **	A/W	Issue No.	15
LM End	18.43	Issue Type +	Ma	Location *	LS
Category	Earthen Levee			GPS Latitude/Longitude	
				Start	End
Item	Underseepage Relief Wells			38.989962 °	38.989962 °
				-121.727896 °	-121.727896 °
DWR ID	DWR_RD1500_02_s_2015_15				
Comment Code					
Inspector Comment

View of the toe drainage at the landward toe berm. Fall 2015.
